Re: Monthly Report Summary #6 for the Sanger Substation Expansion Project

Sanger Substation Expansion Project CPUC Compliance Monitoring Report

Project Proponent	Pacific Gas & Electric (PG&E)	Report No.	CM-CPUCBA-041219
Lead Agency	California Public Utilities Commission (CPUC)	Date (mm/dd/yy)	04/12/19
CPUC Project Manager	Michael Rosauer	Monitor(s)	Ben Arax
CPUC (Ecology and Environment, Inc., member of WSP [E & E]) Monitoring Manager	Ilja Nieuwenhuizen	AM/PM Weather	54°F, partly cloudy, wind 7 miles per hour (mph)
CPUC (E & E) Monitoring Supervisor	Aileen Cole	Start/End Time	9:21 AM – 10:18 AM
Project Notices to Proceed NTP(s)	NTP #1

Project Proponent	Pacific Gas & Electric (PG&E)	Report No.	CM-CPUCBA-042419
Lead Agency	California Public Utilities Commission (CPUC)	Date (mm/dd/yy)	04/24/19
CPUC Project Manager	Michael Rosauer	Monitor(s)	Ben Arax
CPUC (Ecology and Environment, Inc., member of WSP [E & E]) Monitoring Manager	Ilja Nieuwenhuizen	AM/PM Weather	73°F, clear, wind 7 miles per hour (mph)
CPUC (E & E) Monitoring Supervisor	Aileen Cole	Start/End Time	9:00 AM – 9:25 AM
Project Notices to Proceed NTP(s)	NTP #1

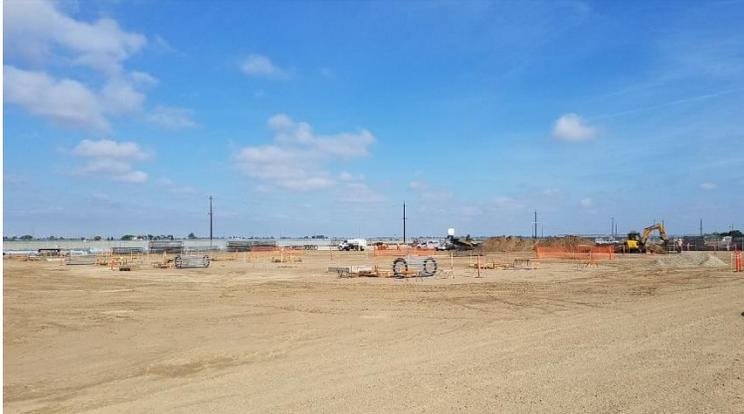
Photo 1- Site conditions on the expansion footprint. Photo facing northwest.
04/12/19	Expansion footprint

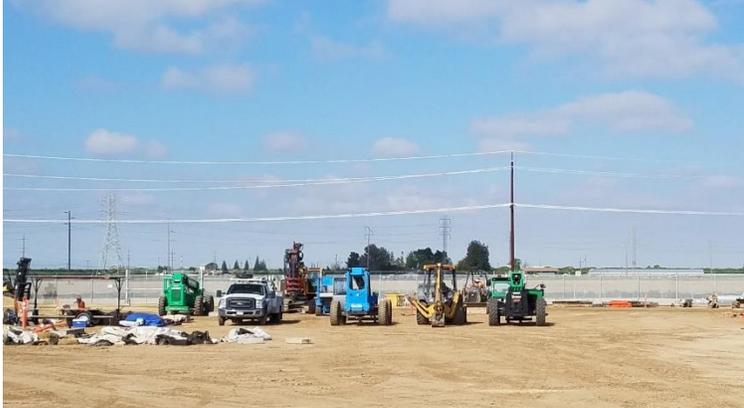
Photo 2- Vehicles turned off and consolidated after use. Photo facing west.
04/12/19	Expansion footprint

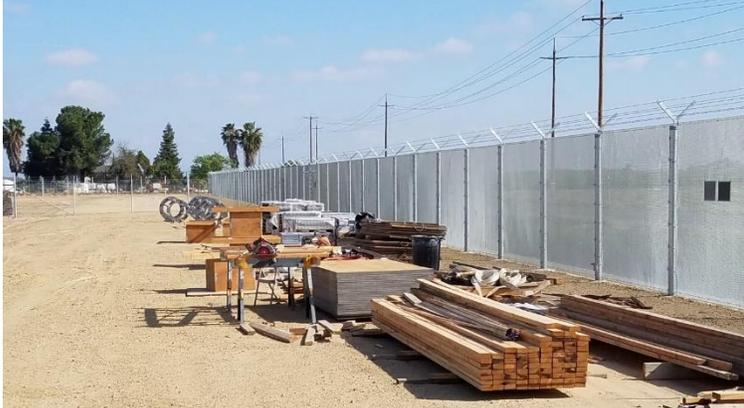
Photo 3- Building materials stored away from foot/vehicle traffic. Photo facing north.
04/12/19	Expansion footprint

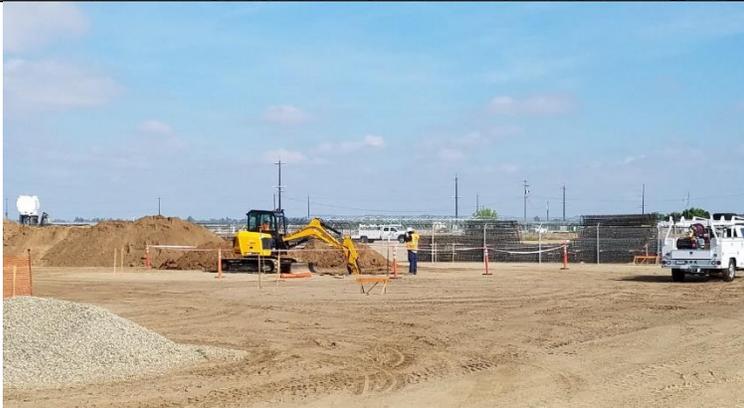
Photo 4- AJ Excavation crew excavating holes for concrete pouring. Photo facing northwest.

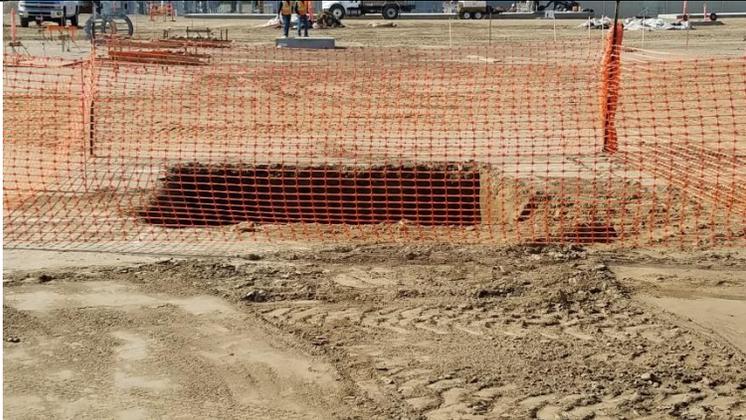
Photo 5- Excavated hole covered with exclusion fencing. Photo facing south.
04/12/19	Temporary staging area

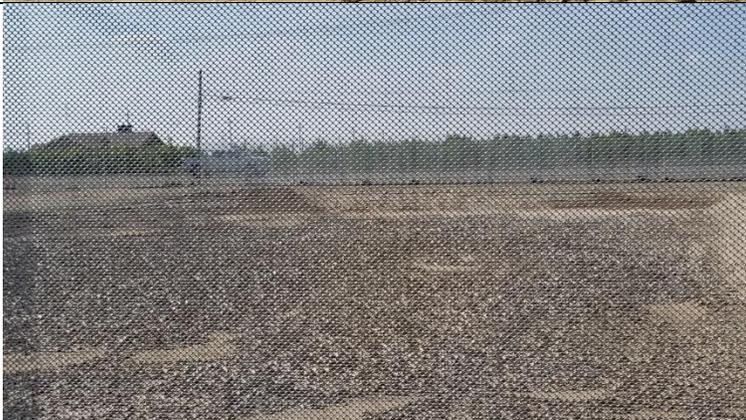
Photo 6- Retention basin fully drained. Photo facing south.
04/12/19	Expansion footprint

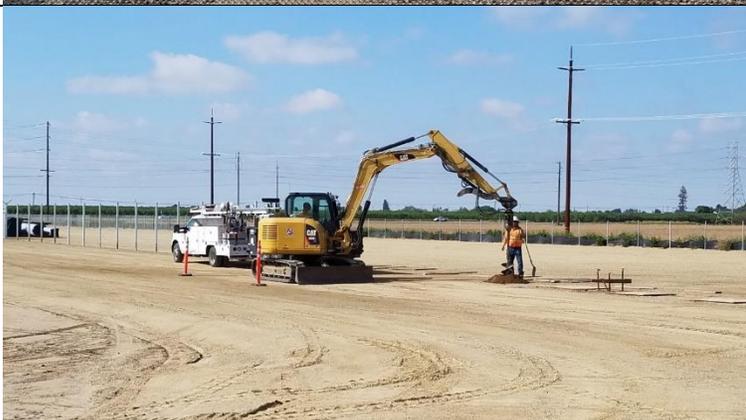
Photo 7- AJ excavation boring fence post holes. Photo facing southwest.
04/12/19	Expansion footprint

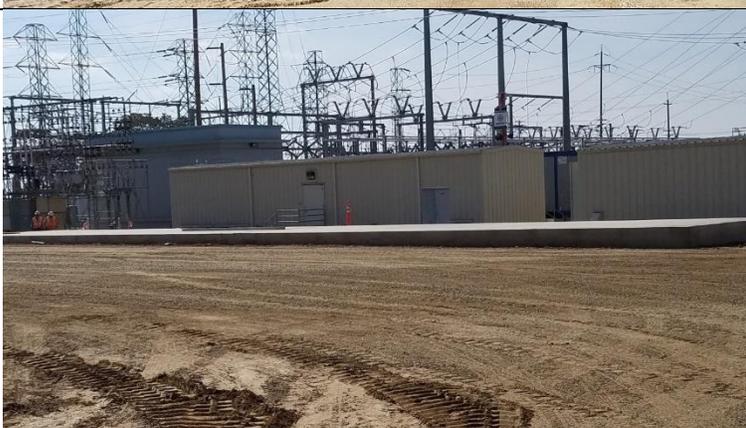
Photo 8- Finished concrete footings for MPAC buildings. Photo facing southeast.

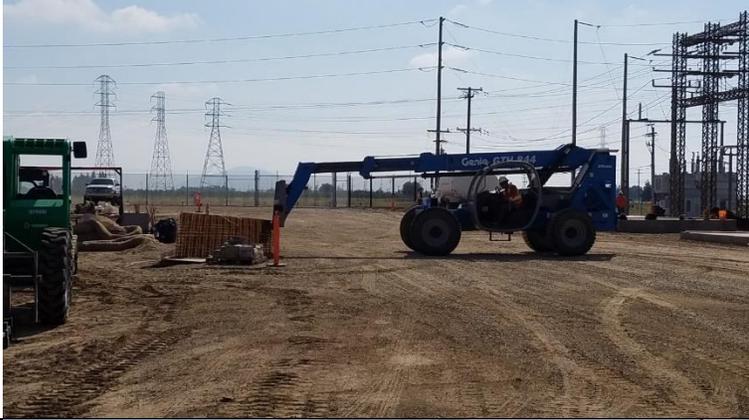
Photo 9- AJ Excavation worker transporting building materials with a forklift. Photo facing east.
40/12/19	Expansion footprint

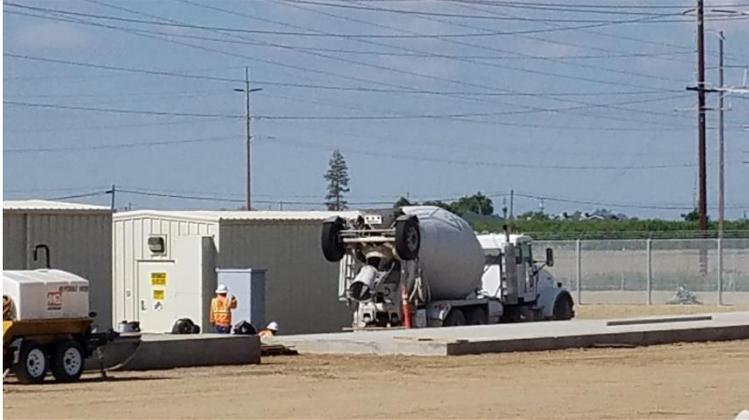
Photo 10- Concrete truck being guided by crew. Photo facing southwest.
04/12/19	Expansion footprint

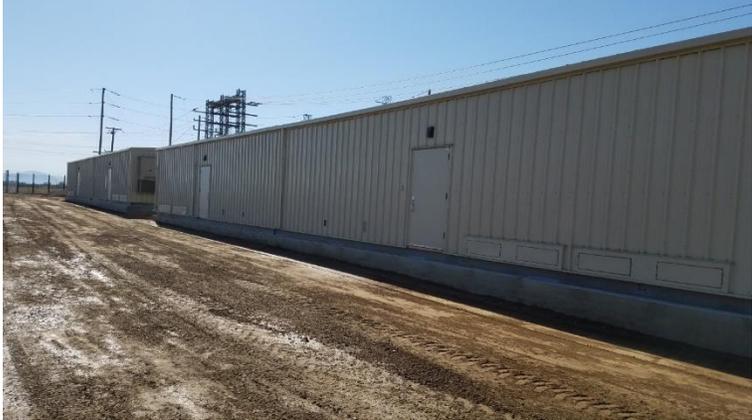
Photo 1- Constructed MPAC buildings. Photo facing southeast.
04/24/19	Expansion footprint

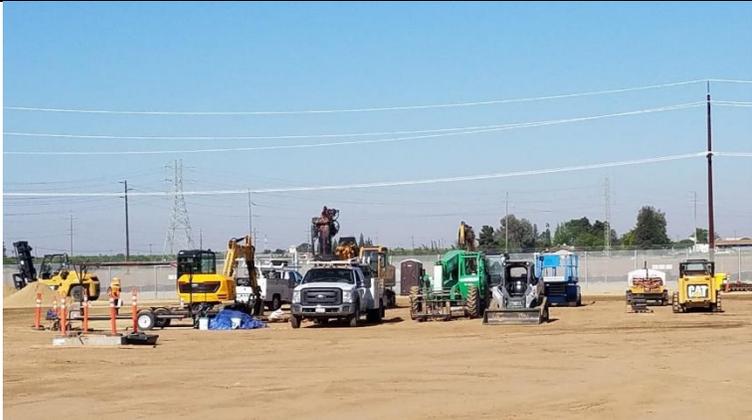
Photo 2- Vehicles turned off and stored together when not in use. Photo facing west.
04/24/19	Expansion footprint

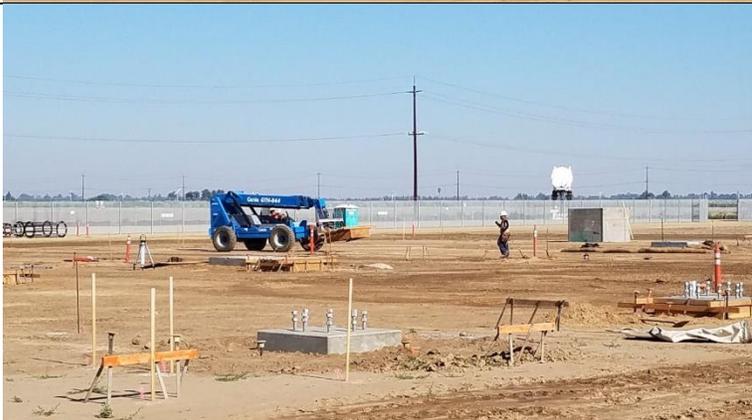
Photo 3- Crew operating a forklift. Photo facing northwest.

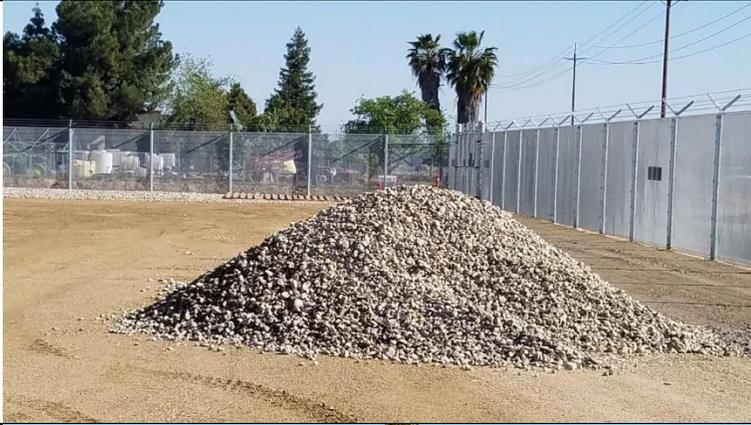
Photo 4- Rock used for truck ingress point temporarily stored. Photo facing north.
04/24/19	Expansion footprint

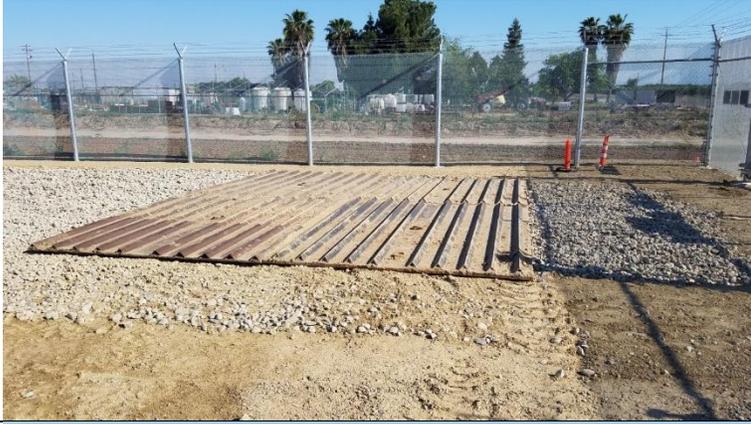
Photo 5- BMPs (Rumble plates/trackout rock) installed at the northeast end of the expansion footprint. Photo facing north.
04/24/19	Temporary staging area

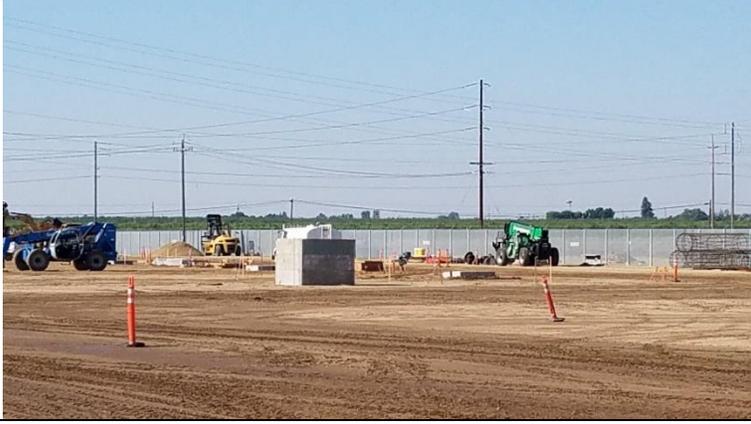
Photo 6- Constructed pole box. Photo facing southwest.

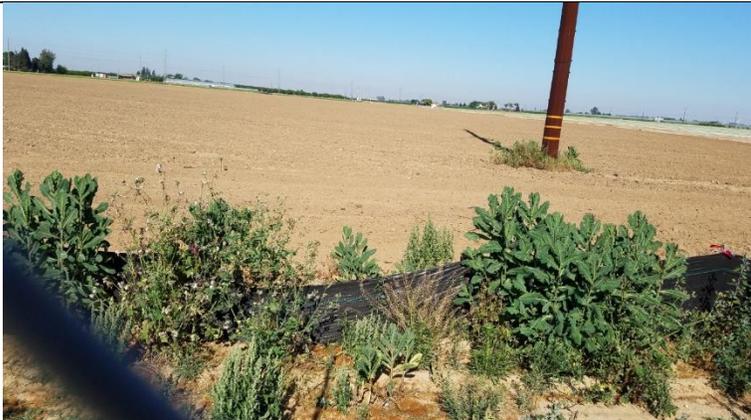
Photo 7- Silt fence intact, but with substantial weeds growing around it. Photo facing west.
04/24/19	Temporary staging area

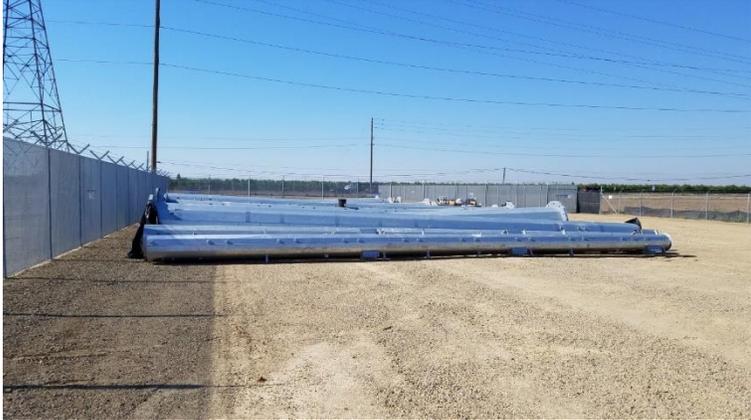
Photo 8- Building materials placed in temporary staging area. Photo facing south.
04/24/19	Expansion footprint

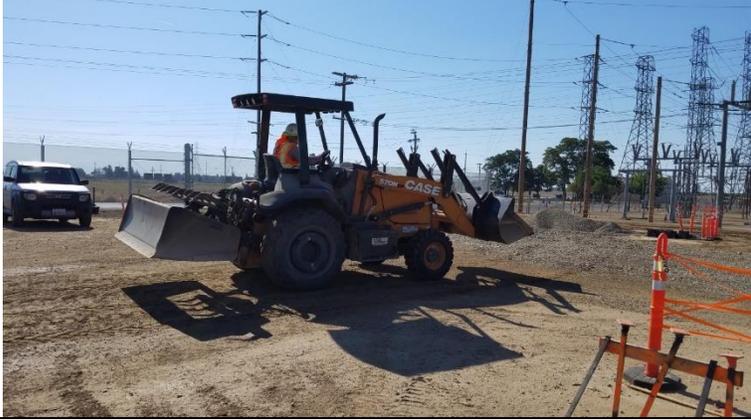
Photo 9- Crewmember operating a front-end loader, transferring rocks to the northern end of the expansion footprint. Photo facing southeast.
